Correcting a Blister Problem on Windward Passage

- Work done by Rick's Marine Service
- Rock Hall, Maryland
- Work begun: December 18, 2004
- Work completed: April 22, 2005

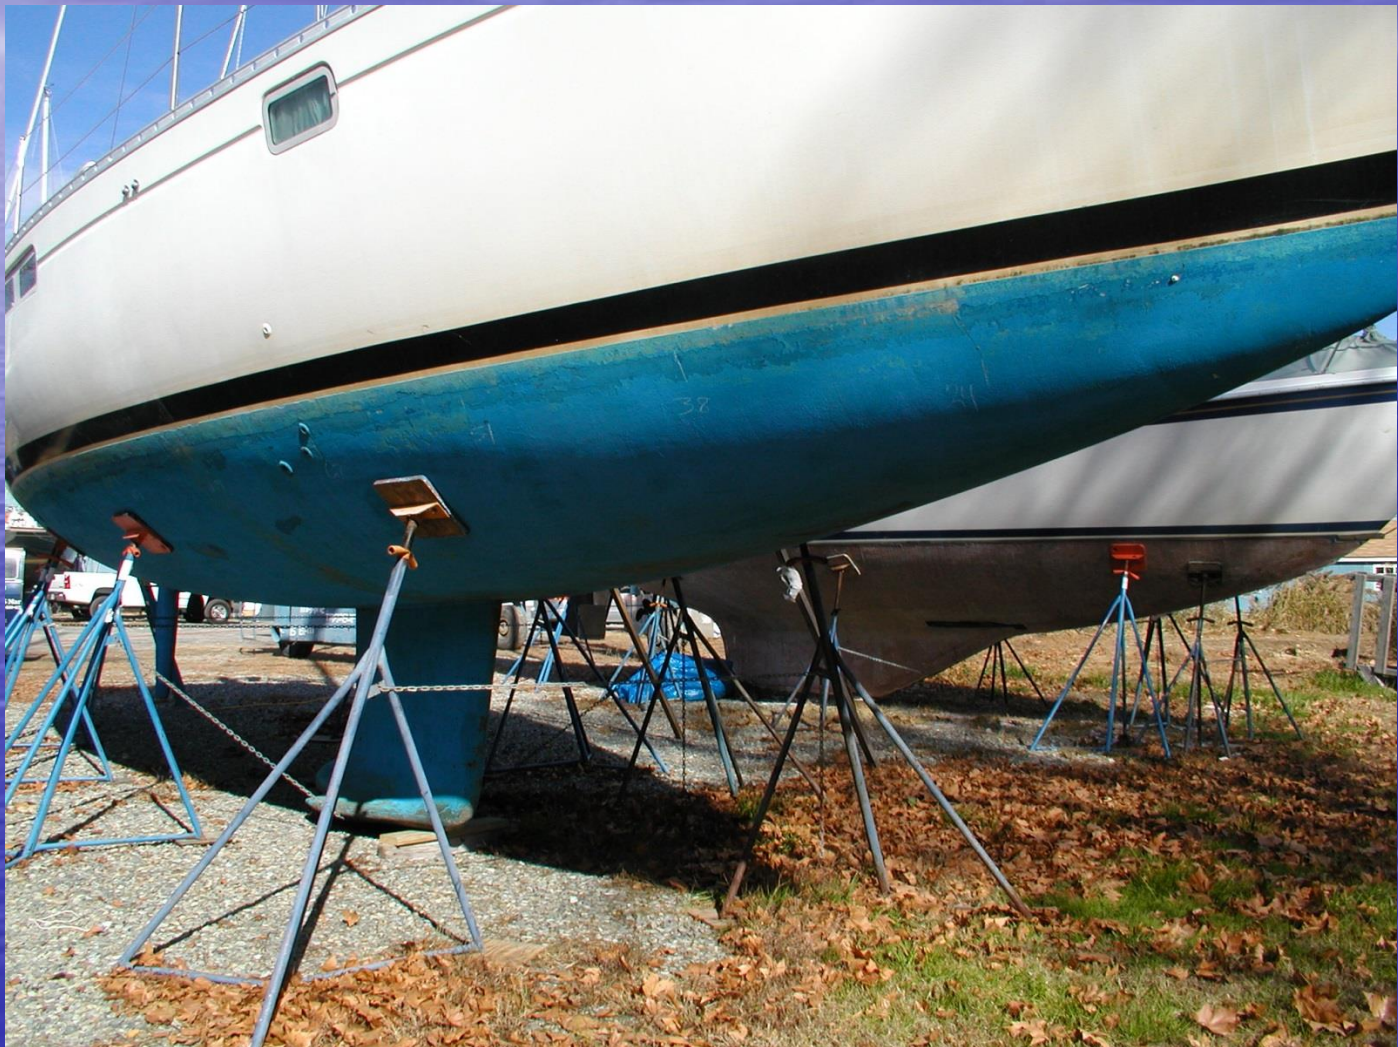
Bottom had many coats of paint

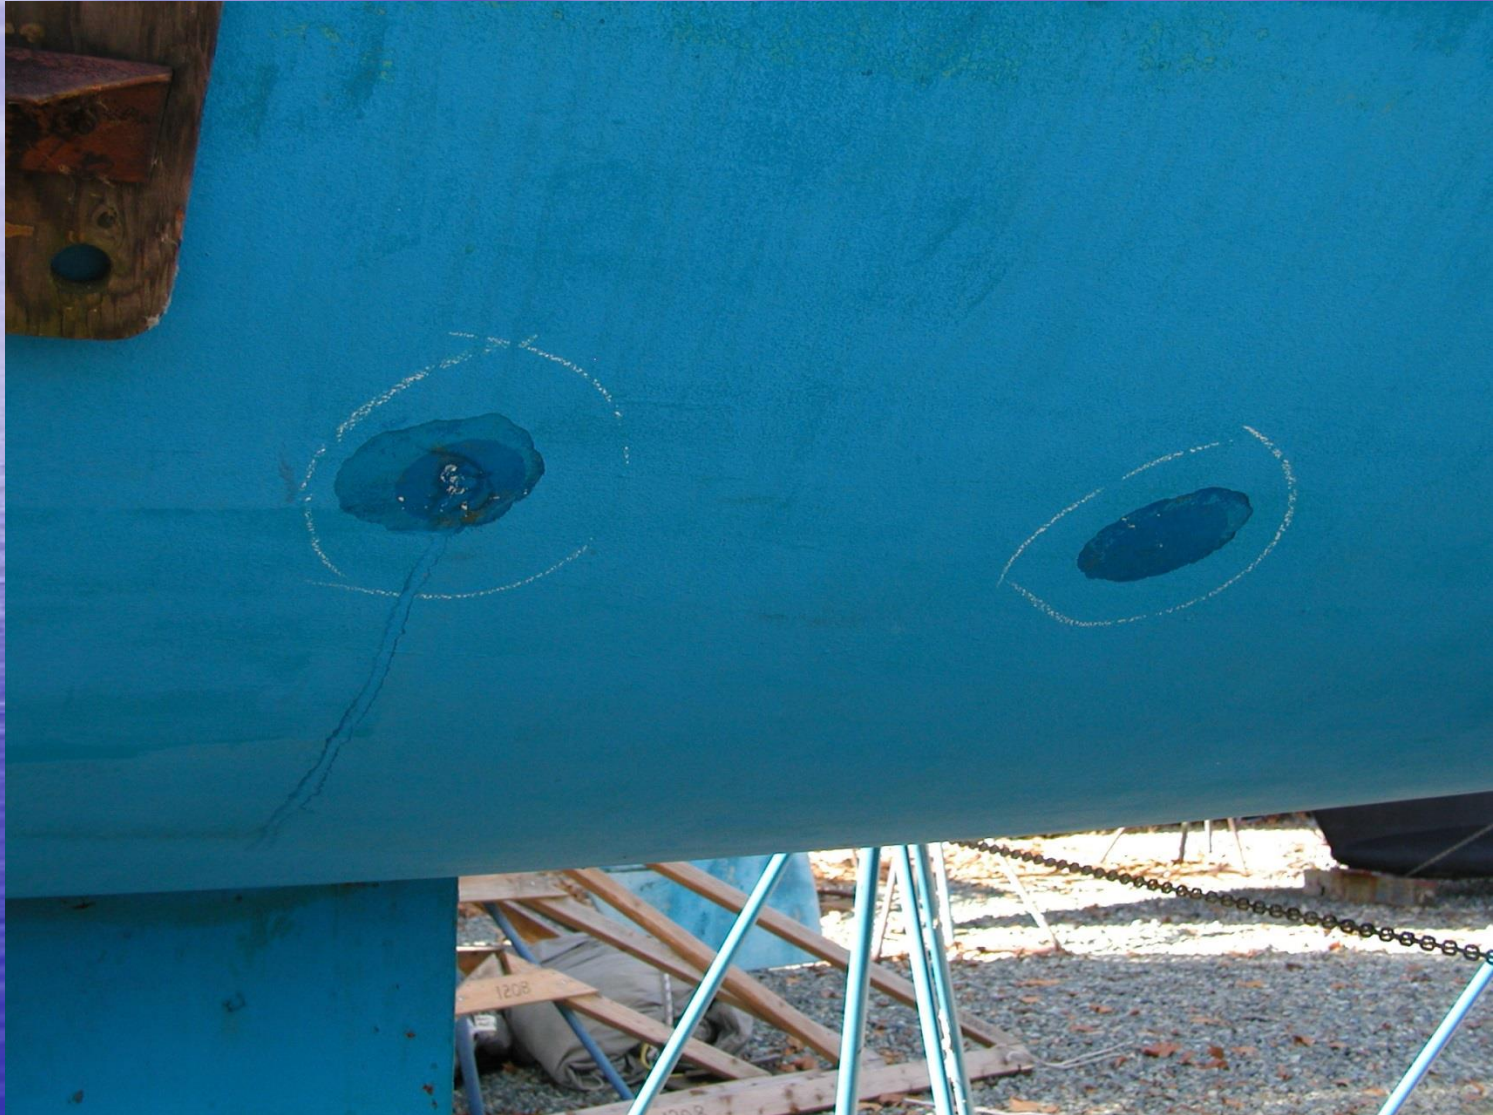
Over 10 plate-sized blisters

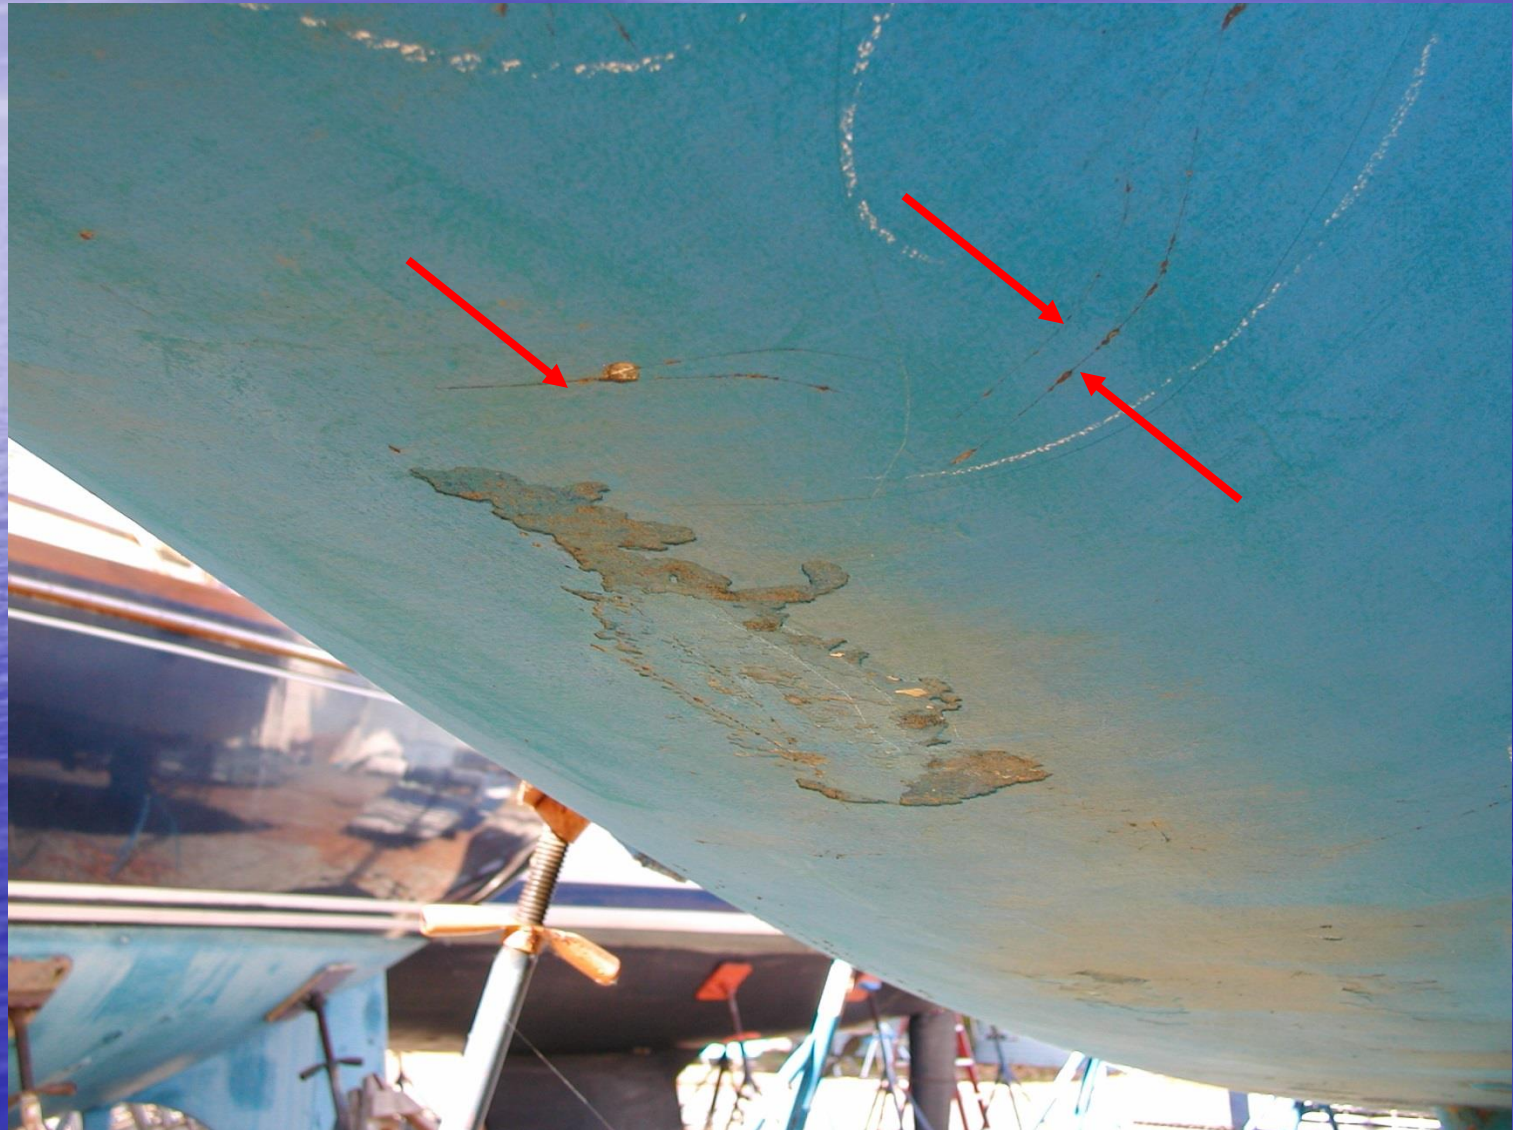
Extensive cracks in the gel coat

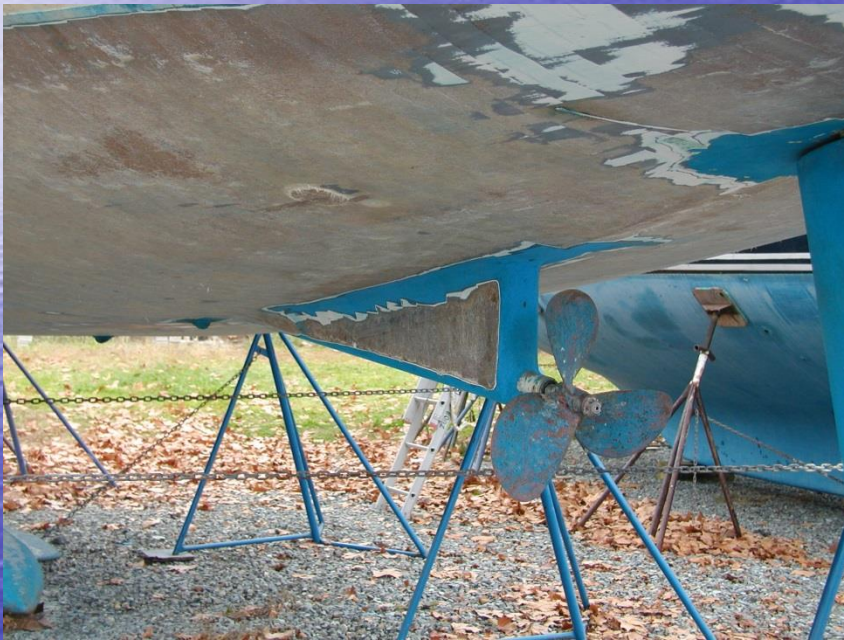
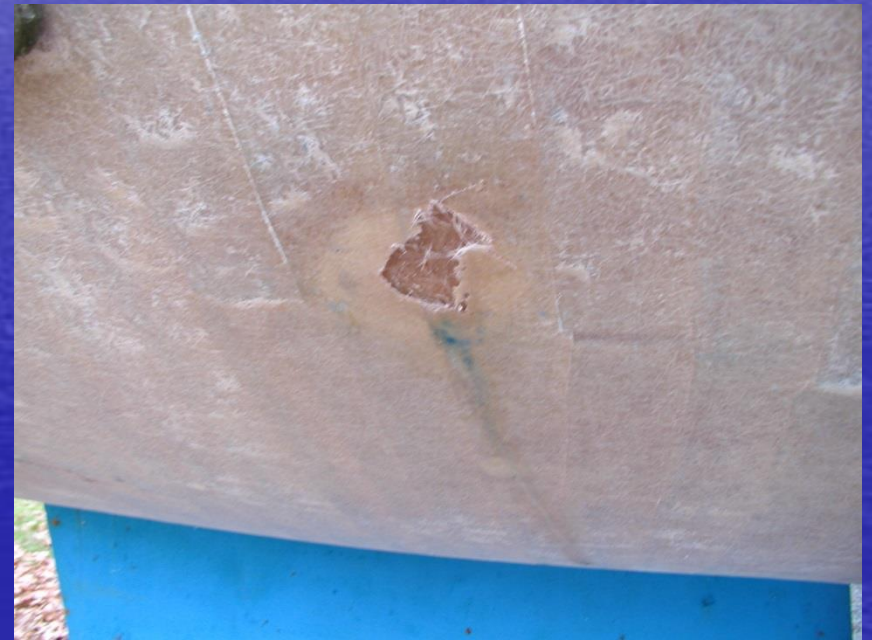
Bottom After First Peel

Note some gel coat remaining and two layers of fiber glass not completely removed after first peel

- Mechanical peeler removes up to 1/8 inch per pass
- Objective is to remove paint, gel coat and two layers of fiberglass
- Excessive thickness of bottom paint (nearly 1/8") required that the hull be peeled twice to get through the paint, the gel coat and two layers of fiberglass

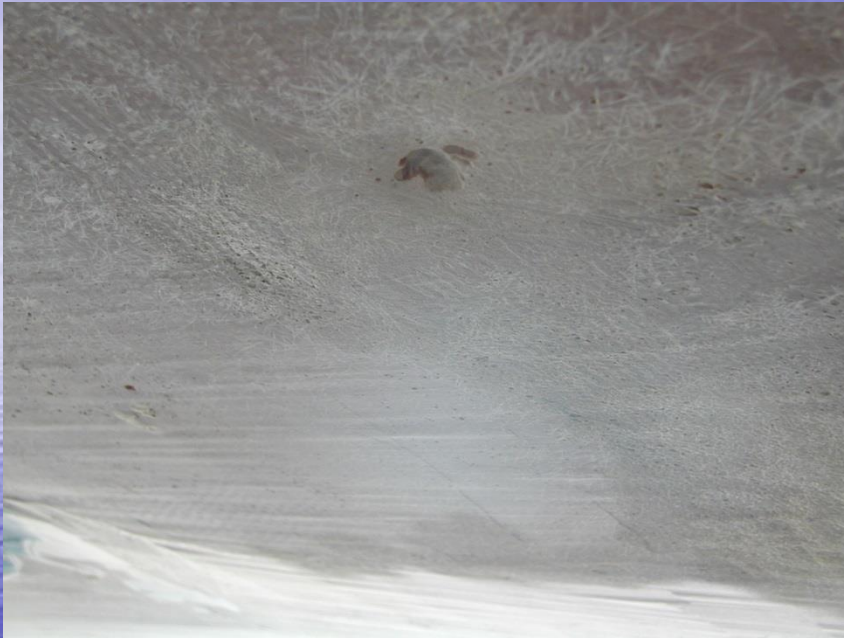
Sandblasting Results

Note the void where the blister had been. This will be filled with epoxy/glass mixture.

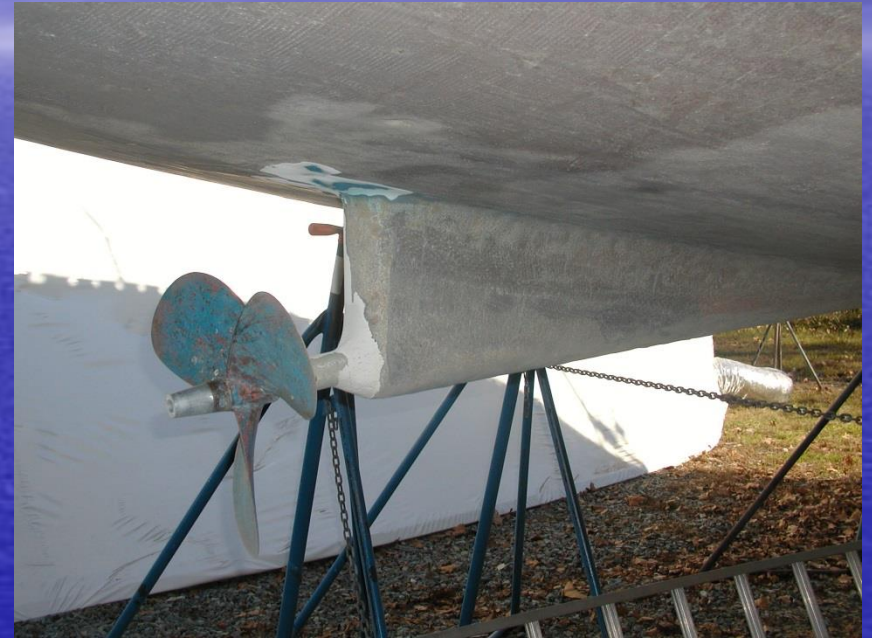
The color and surface texture differences indicate where the sandblasting has been done – the area to the right

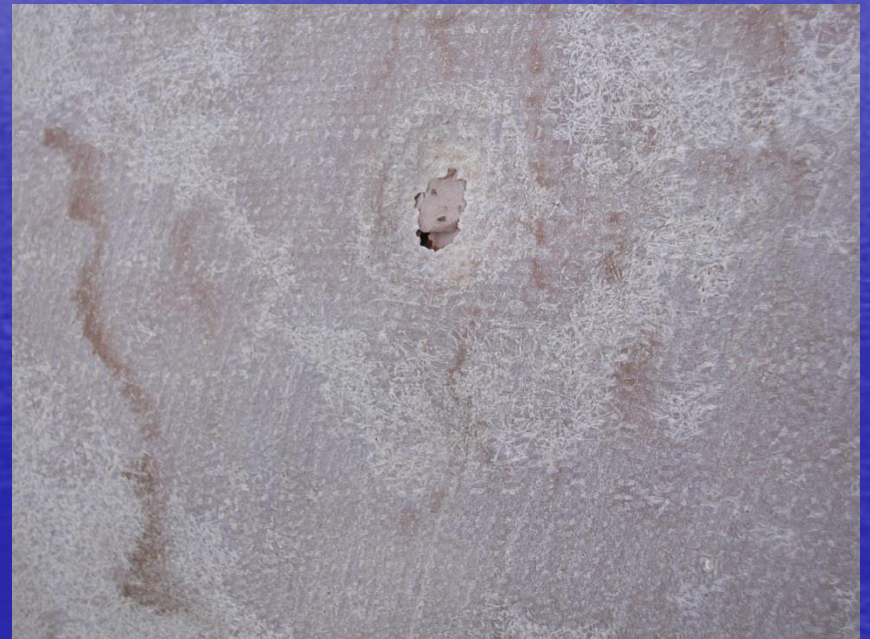
Hull Defect

- Sandblasting revealed a hole through to the inner hull
- This hole had been a major void that was patched when the hull was originally built but removal of the fiberglass and sandblasting removed the patch
- This was repaired with fiberglass and epoxy

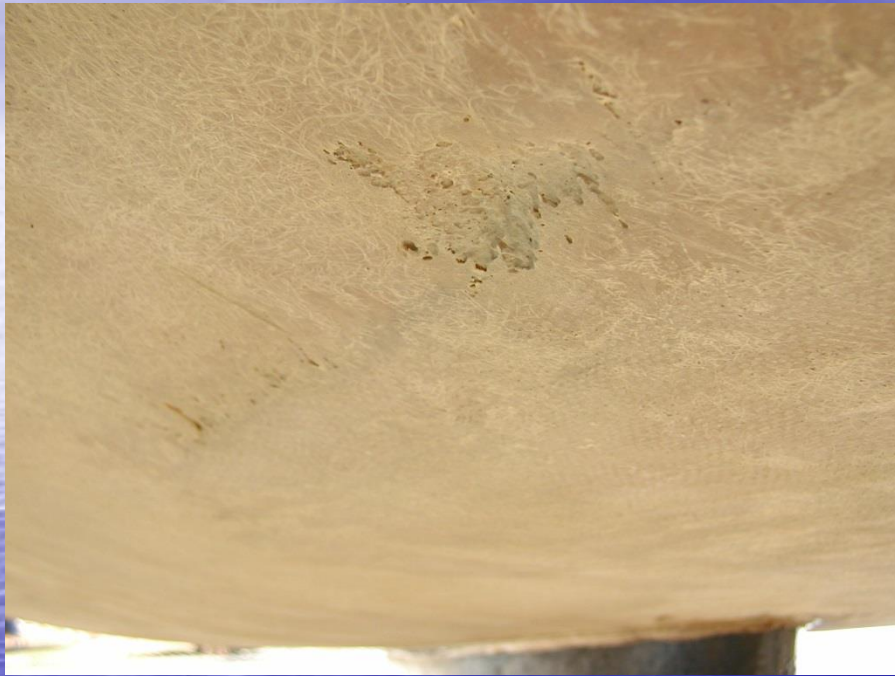
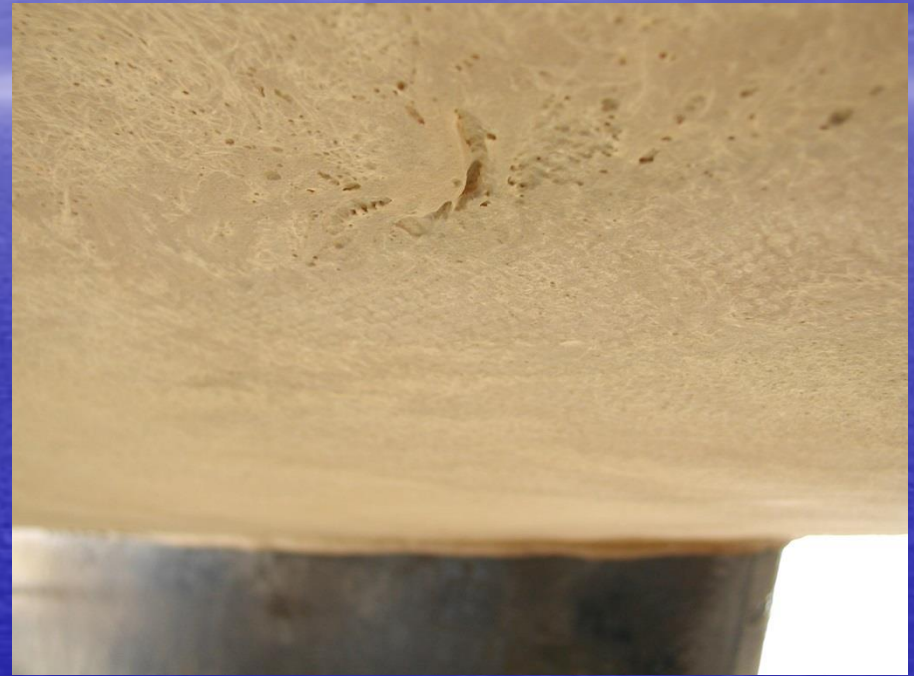
Voids Show Up After Sandblasting

More than a dozen voids of this type were exposed by the sandblasting operation at least some were from the manufacturing operation. Others may be products of blisters

- Hull is dried for several days in the heated tent until the moisture meter shows no residual moisture
- Major voids are first filled with epoxy resin (black areas)
- Then two coats of thinned vinyl ester resin are applied with a roller over the entire hull
