Correcting a Blister Problem on Windward Passage

- Work done by Rick's Marine Service
- Rock Hall, Maryland
- Work begun: December 18, 2004
- Work completed: April 22, 2005

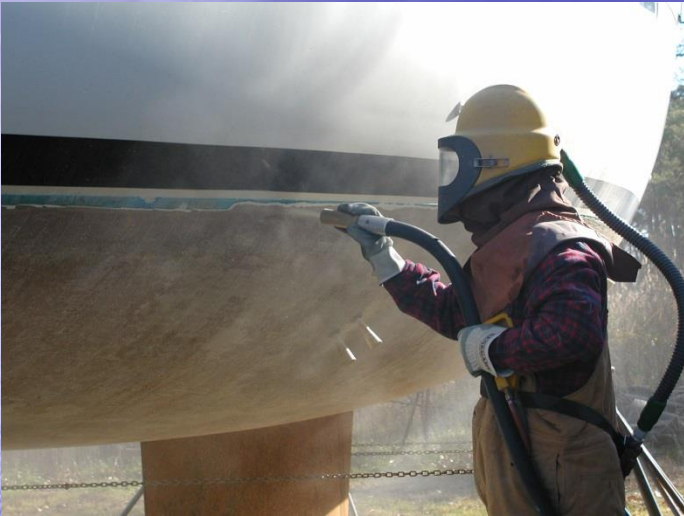
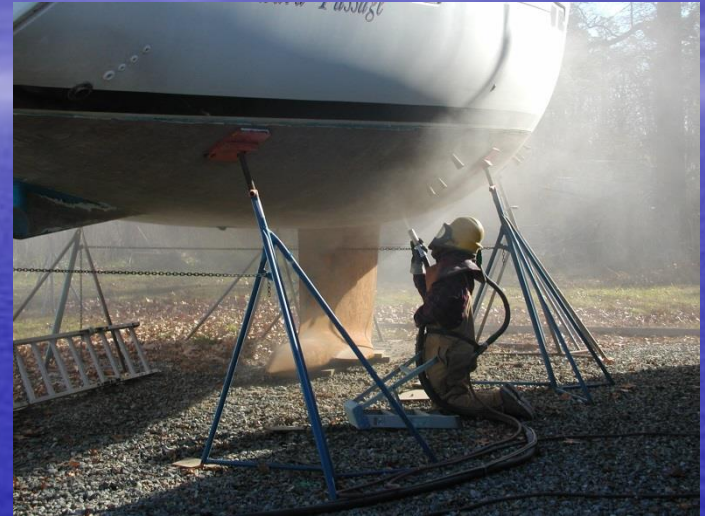
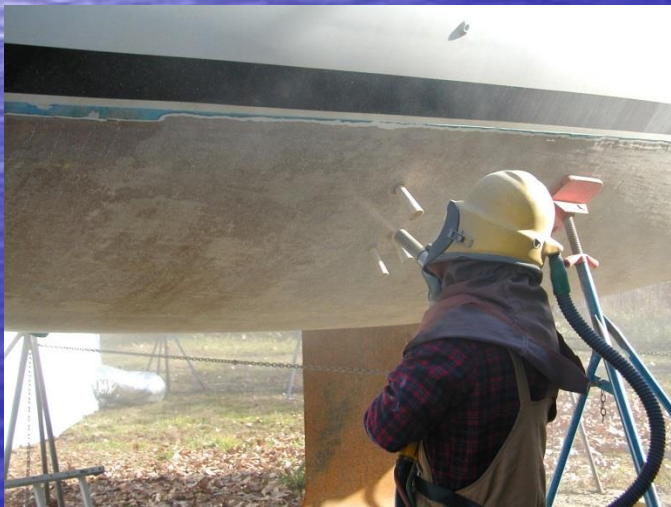
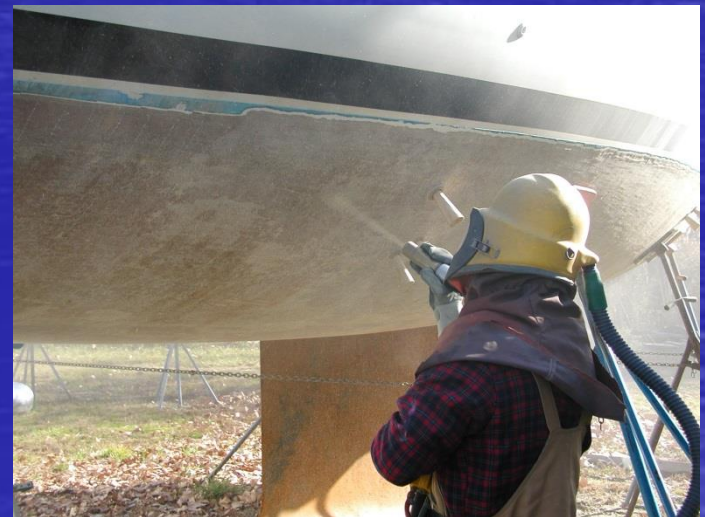
Sandblasting Operation

- After the second peel the hull is sandblasted to remove loose material
- This also cleans out blisters and voids
- This process takes the hull down to dry fiberglass

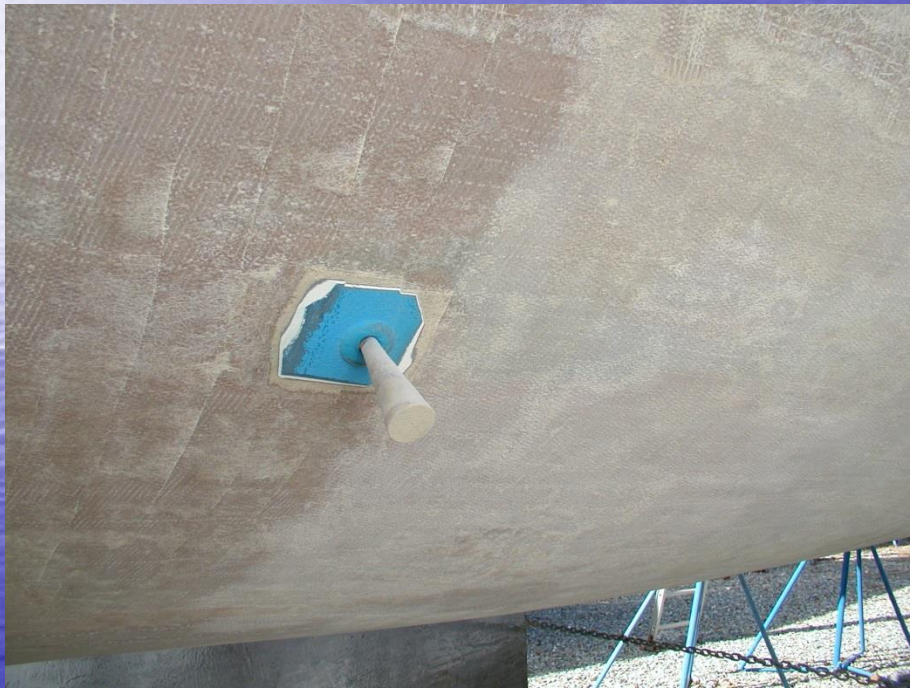
Sandblasting Results – cont.

Left: Before sandblasting
Right: After Sandblasting

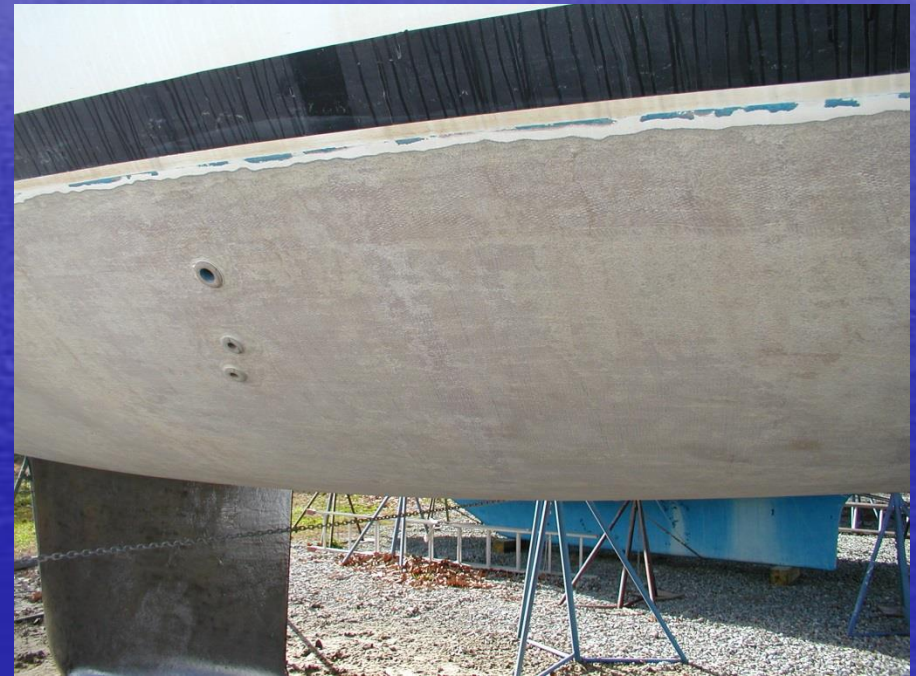
This part of the hull has been completely sandblasted

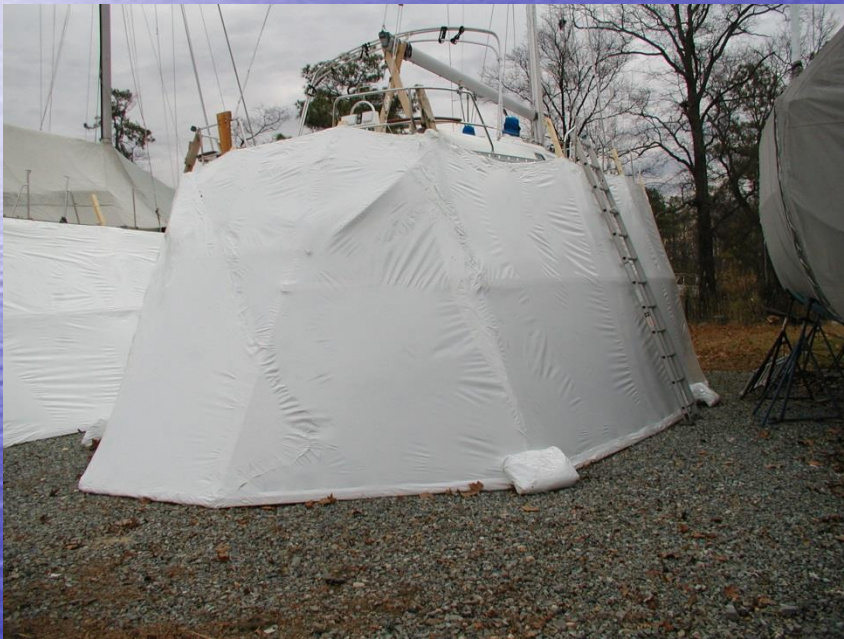
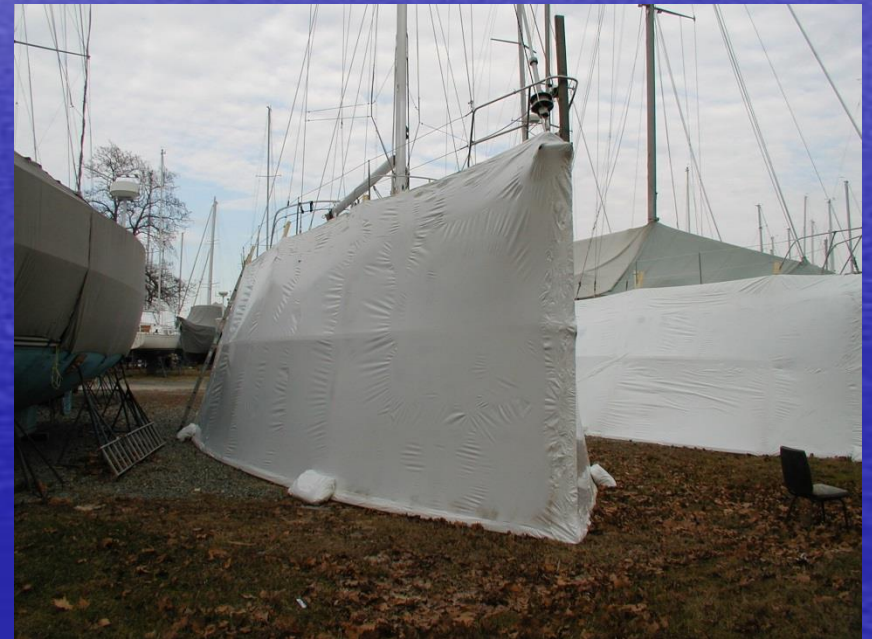
After Sandblasting, a Tent is Built

An external heater mounted on a trailer will maintain the temperature in the tent above 60° F while the resin is curing

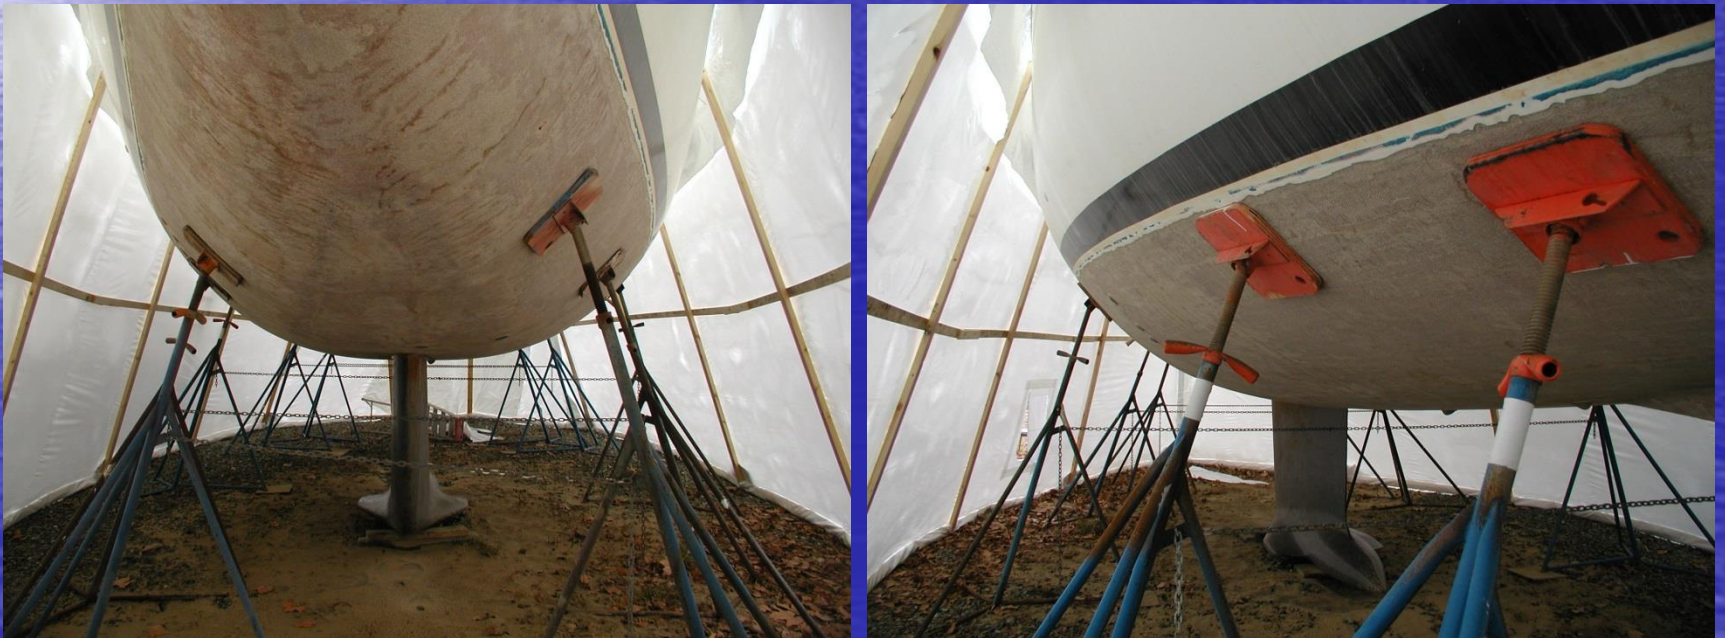
Inside Tent – Dry and Warm

Though the outside temperature dropped as low as 8° F the temperature in the tent was above 60° F
